NATIONAL TRANSPORTATION SAFETY BOARD

MATERIALS LABORATORY FACTUAL REPORT

Report No. 16-004

Place : Plainview, Illinois
Date : October 26, 2014
Vehicle : Sonex HB, N244HB
NTSB No. : CEN15LA028
Investigator : Mitchell Gallo, ASI-CEN

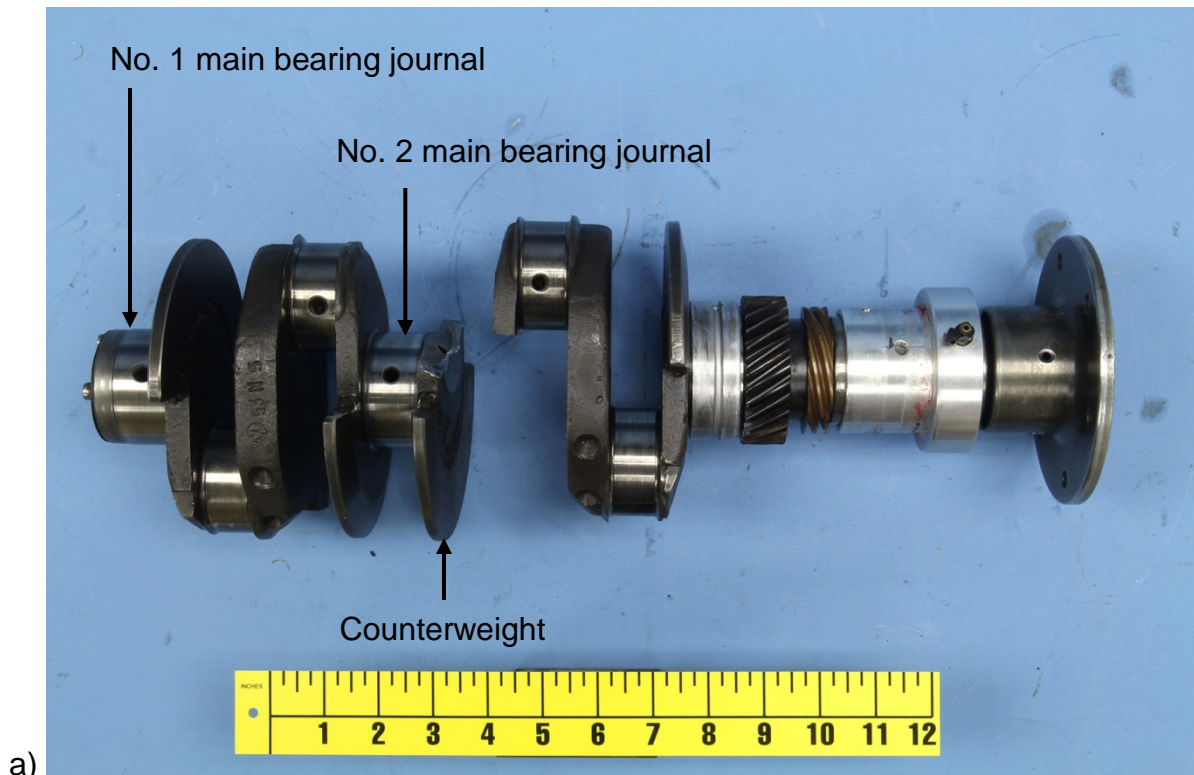
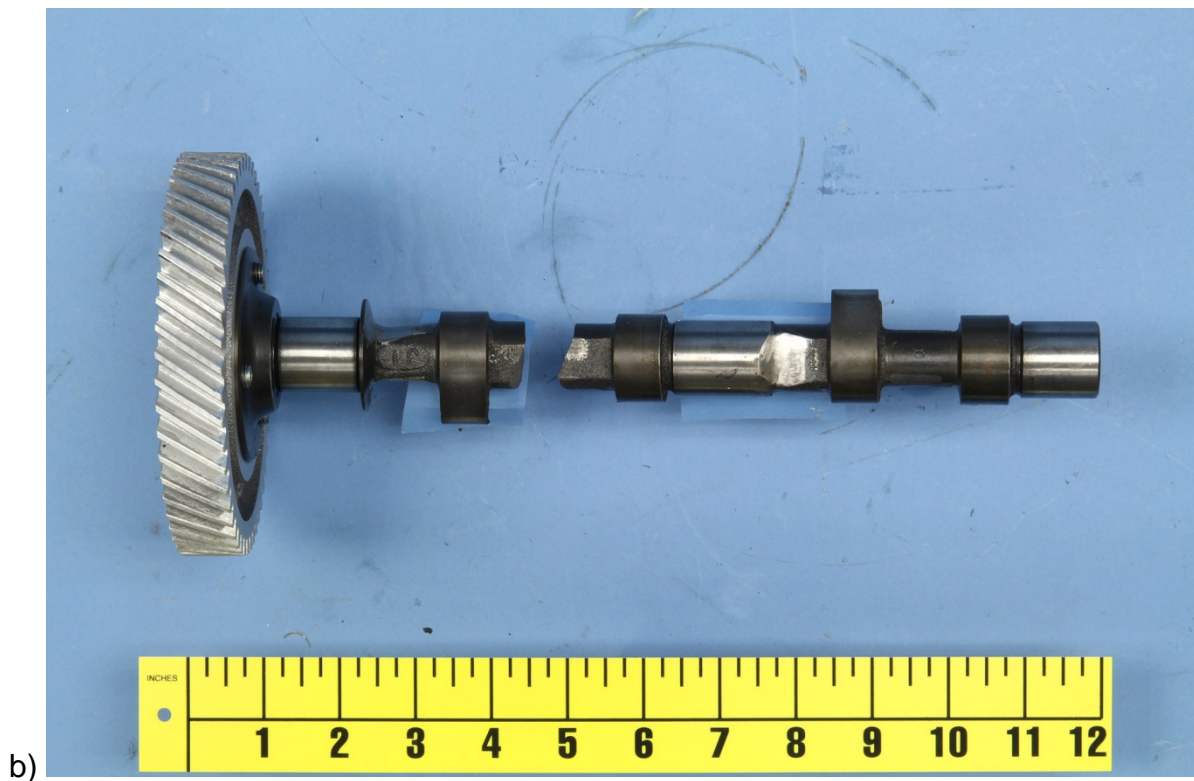
A fractured crankshaft and fractured camshaft from a Great Plains Aircraft Supply kit engine were sent to the NTSB Materials Laboratory for examination, as shown in figures 1a and 1b. The crankshaft was fractured through the forward cheek of the number 2 main bearing (with numbering starting from the aft end of the engine). The camshaft was fractured between the number 1 and number 2 lobes (with numbering starting from the aft end of the engine). Notable entries in the aircraft logbook are shown in table 1.

Figure 1: a) Image of the fractured crankshaft, as received; b) Image of the fractured camshaft, as received.

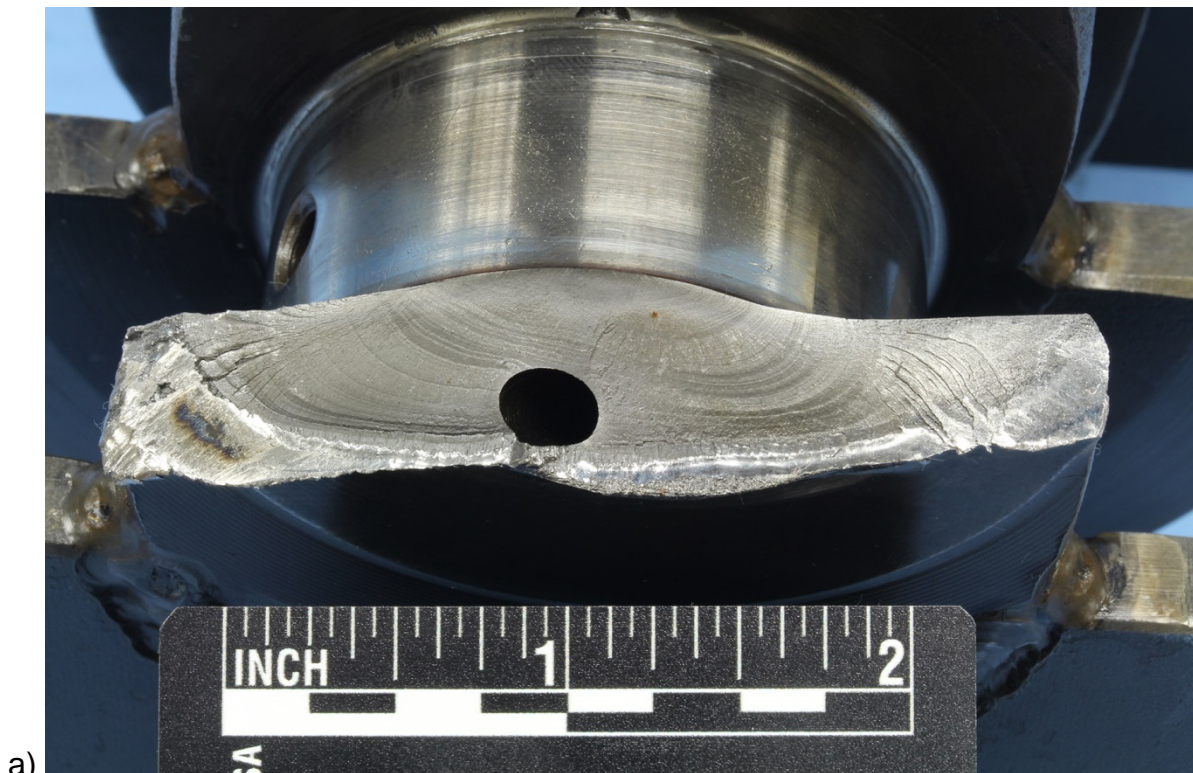
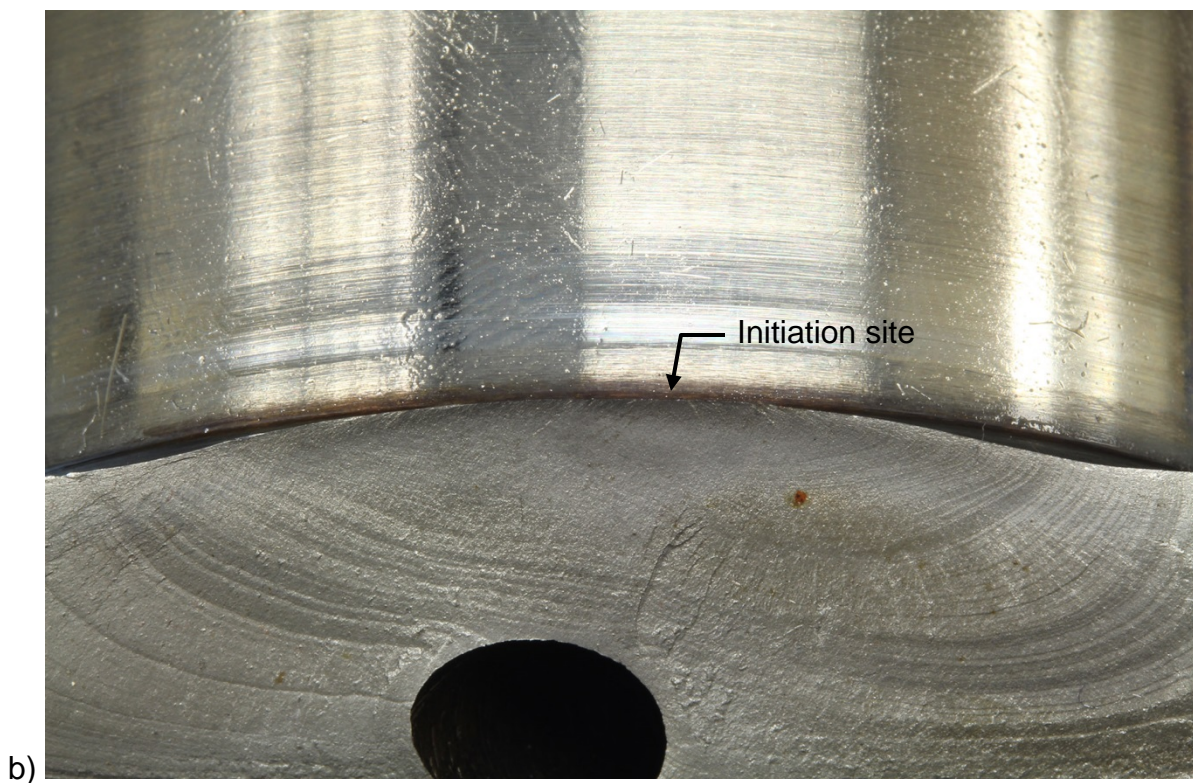
The crankshaft fracture surface was examined visually and one half of the fracture was photographed as shown in figures 2a and 2b. The fracture surface was comparatively flat and exhibited a series of curved crack arrest marks. The features were consistent with a fatigue crack initiating at the intersection of the number 2 main bearing journal with the forward cheek, as indicated in figure 2b.

Figure 2: a) Image of the fractured cheek forward of the number 2 main bearing journal; b) Higher magnification image of the fracture indicating the initiation site.

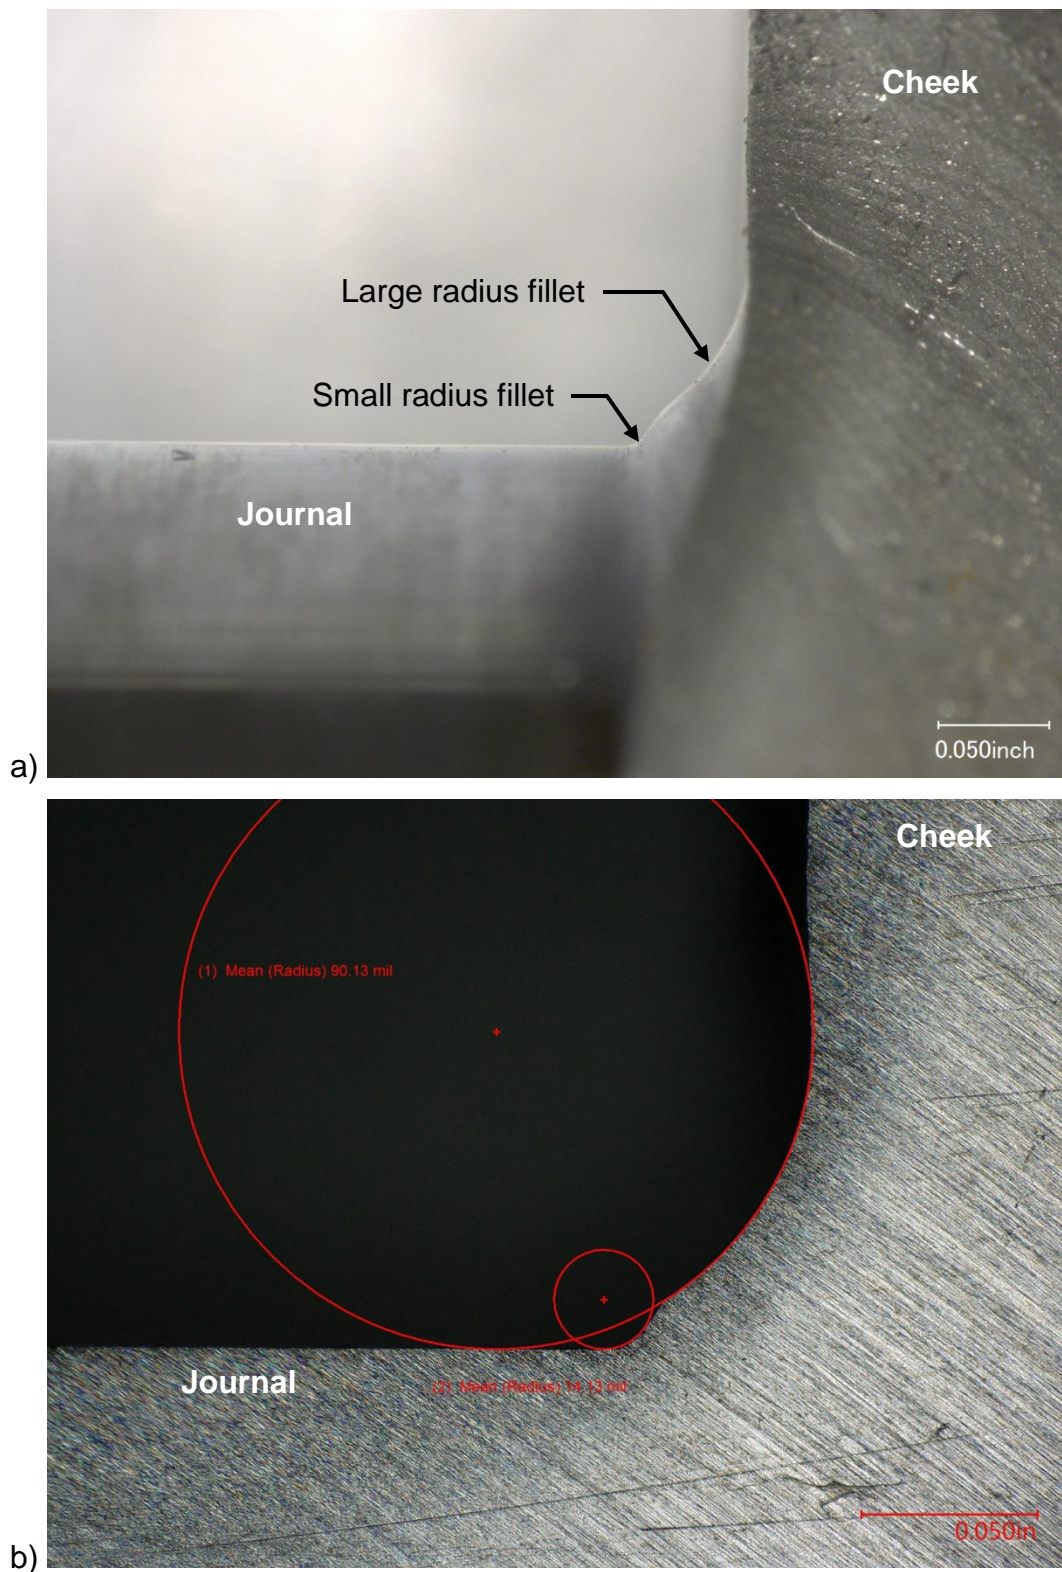
Visual examination revealed that the transition from the journal to the cheek consisted of a small radius fillet that blended into a large radius fillet, as indicated in figure 3a. The journal was sectioned through the transition with an abrasive cutting saw and photographed, as shown in figure 3b. The radius of each fillet was measured on the calibrated digital image. The fillet radii were approximately 0.090 inch and 0.014 inch for the large and small radius fillets, respectively. The transition from the number 2 journal to its aft cheek and the number 1 journal to its forward cheek similarly exhibited small diameter and large diameter fillet radii, as shown in figures 4a and 4b, respectively.

Figure 3: a) Image of the journal to cheek fillet at the forward edge of the number 2 main bearing journal; b) Section through the journal used to measure the size of the large and small radii.

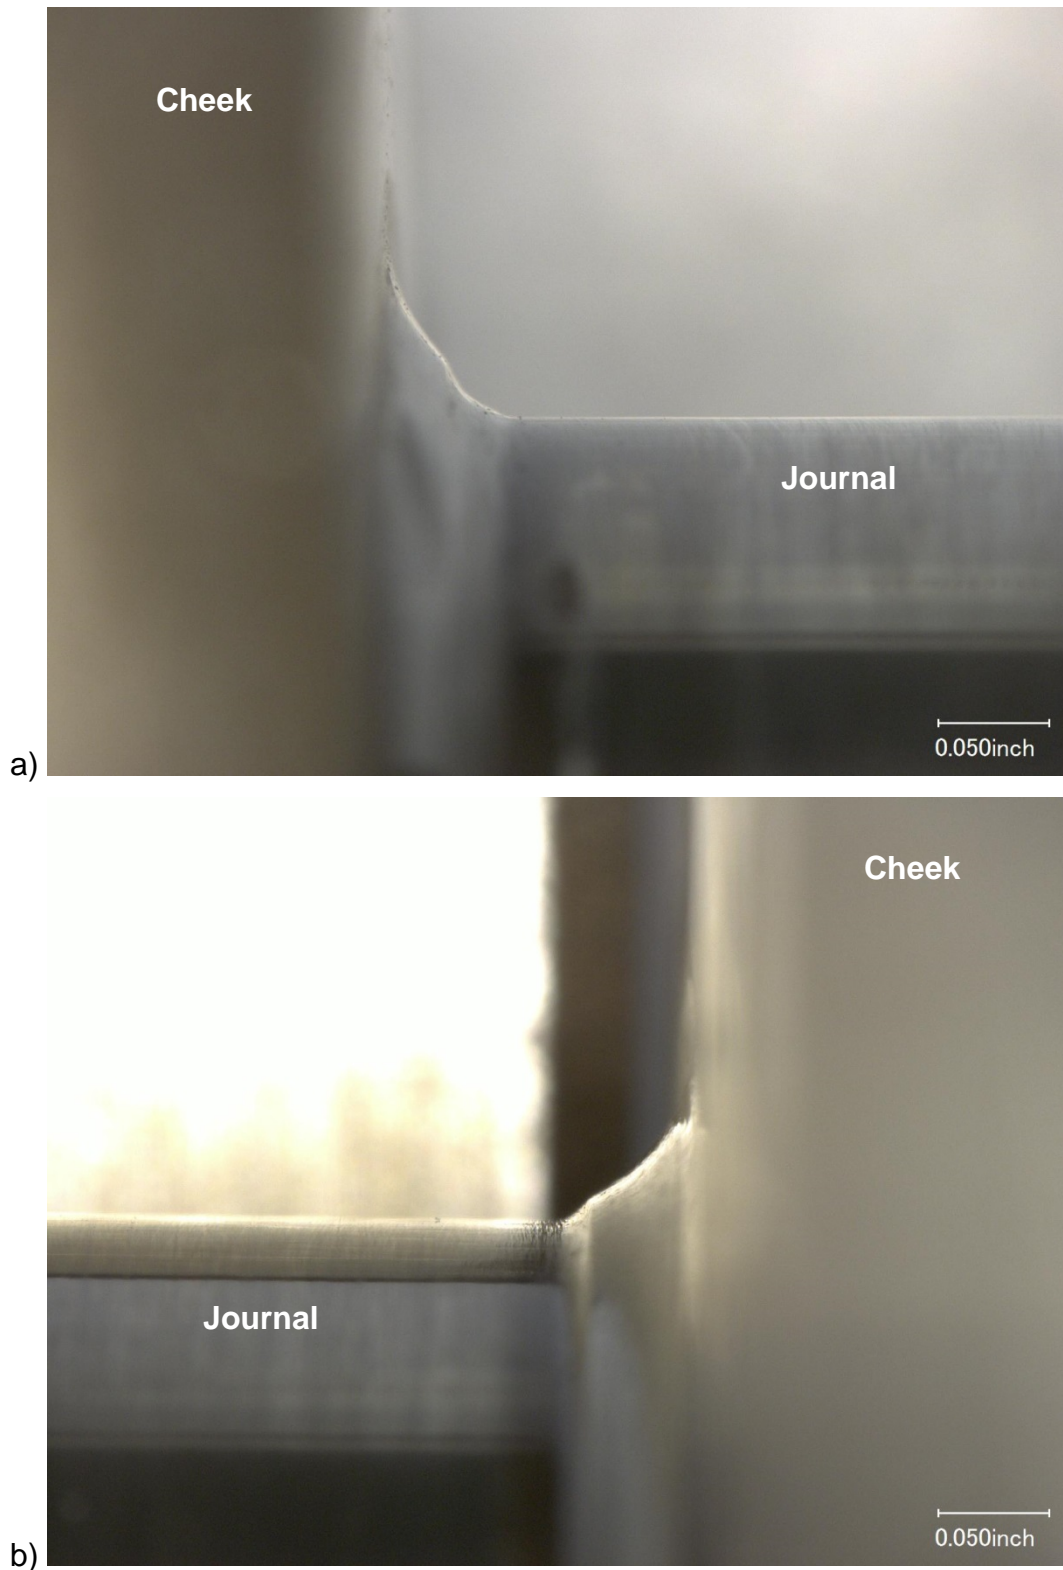
Figure 4: a) Image of the journal to cheek transition at the aft end of the number 2 main bearing journal; b) image of the journal to cheek transition at the forward end of the number 1 main bearing journal.

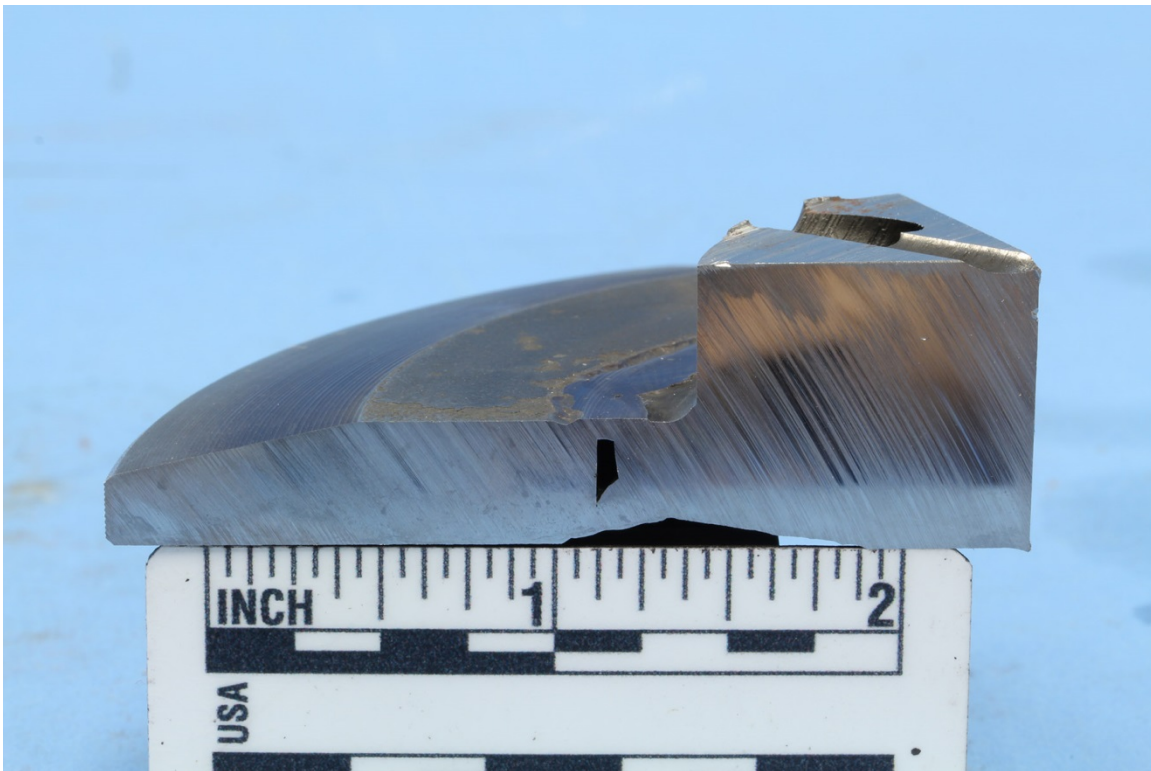
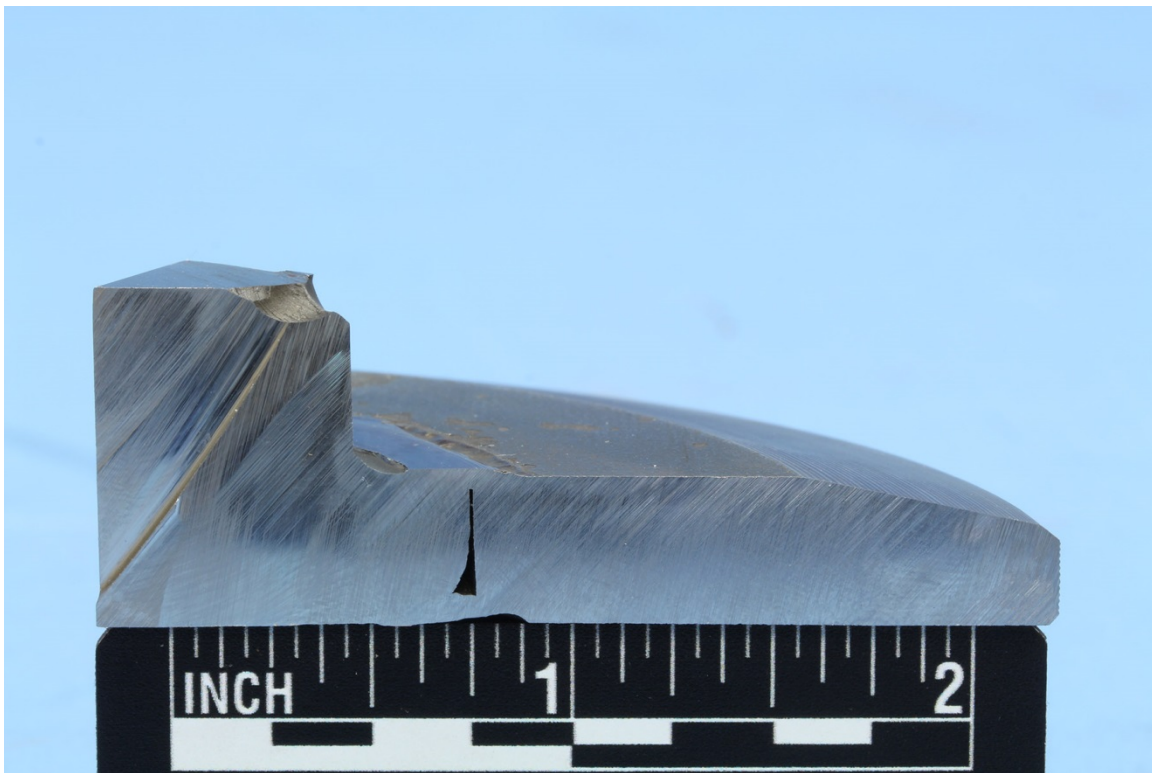
While sectioning the number 2 journal, the counterweight forward of the number 2 main journal, labelled in figure 1a, was also sectioned. The counterweights were made from arc-shaped pieces of steel welded to the crankshaft. Welds were applied on both the forward and aft faces of the counterweights and the crown of each weld was removed to be flush with the face of the counterweight. The sectioned piece of counterweight is shown from two directions in figures 5a and 5b. The welds penetrated through approximately 42% and 30% of the wall thickness in figures 5a and 5b, respectively.

Figure 5: a) and b) Images of two sections through the counterweight forward of the number 2 main bearing journal.

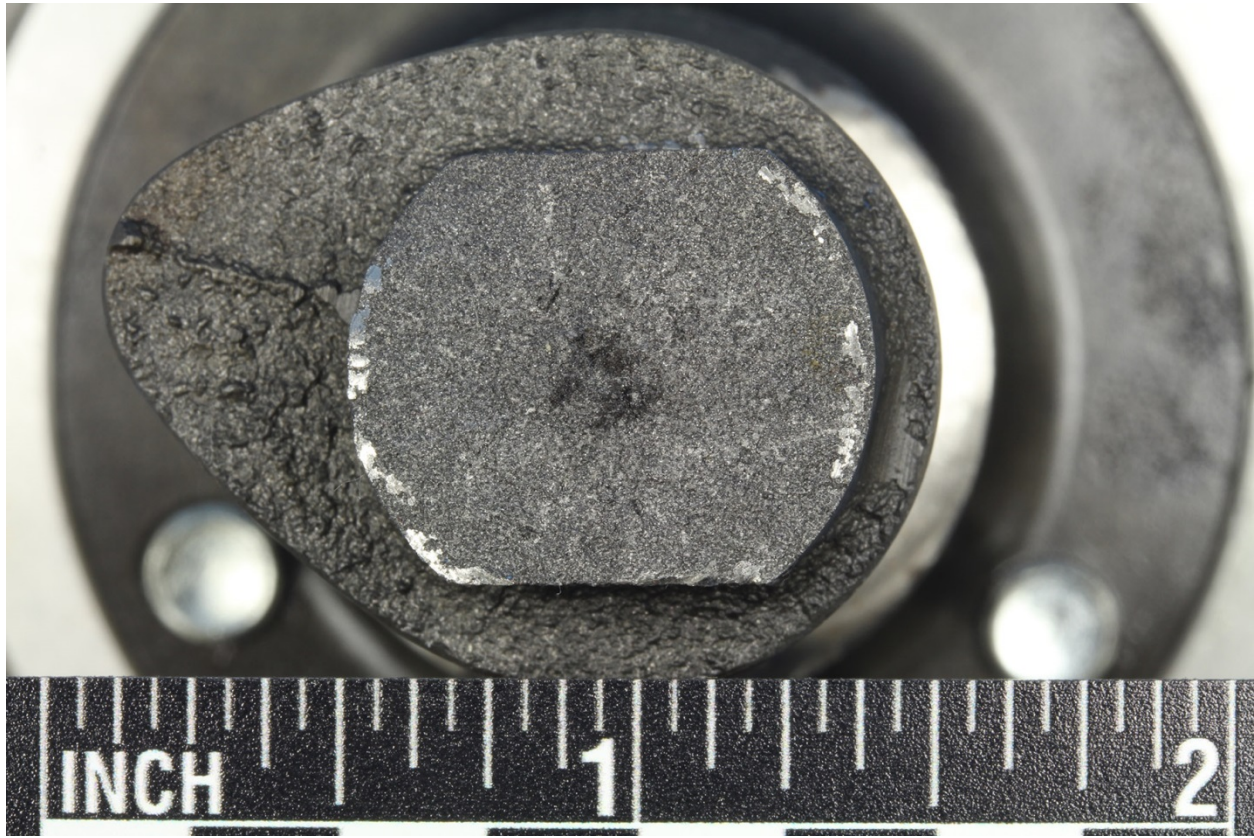
Figure 6: Image of the fracture through the camshaft forward of the number 1 lobe.
